County of San Luis Obispo Onsite Environmental Coordinator  
Guadalupe Weekly Update 01-06-2010

Major construction/remediation activities continue at the Chevron Guadalupe Oil Field Remediation Site (Field) this week. The San Luis Obispo County Onsite Environmental Coordinator (OEC) continues to be present at the Field on a daily basis.

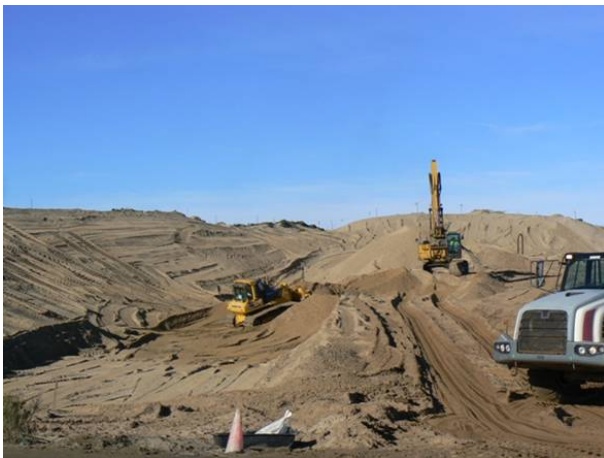
**B5A excavation of clean overburden, late December**

- Chevron/Recon continues removing clean overburden from the site. All clean overburden is stockpiled at the approved E4A stockpile. Any affected material encountered is taken to TB8. As of December 31st, Recon has hauled approximately 37,125 c.y. of clean overburden from this site to the E4A Stockpile area. Any pipelines encountered during clean overburden removal are removed to TB8.
- During vegetated overburden removal, the URS staff identified two diluent contaminated areas west of the sheetpile wall limits. Chevron/URS have collected hand auger samples west of the sheetpile wall and will be presenting a modified work plan of action for agency approval in the next two weeks.

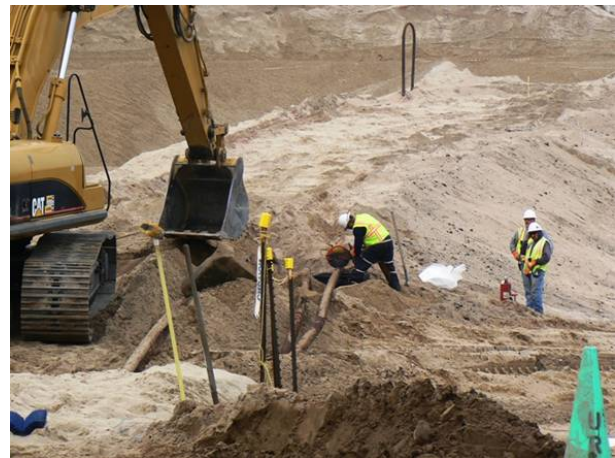
**B5A: hot-tapping pipelines before their removal.**

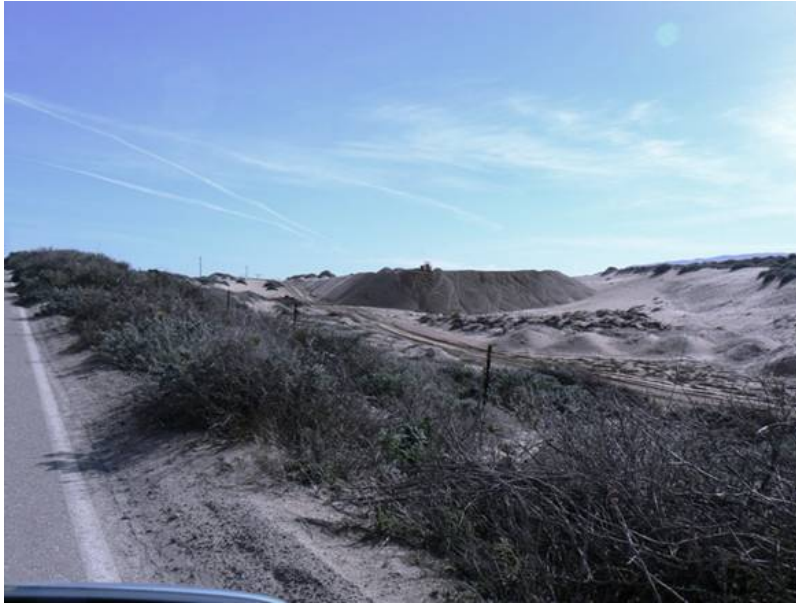
**E4A clean overburden stockpile site (site now contains at least 37,125 cubic yards of clean overburden from the B5A site).**
