County of San Luis Obispo Onsite Environmental Coordinator  
Guadalupe Weekly Update 02-3-2010

Major construction/remediation activities continue at the Chevron Guadalupe Oil Field Remediation Site (Field) this week. The San Luis Obispo County Onsite Environmental Coordinator (OEC) continues to be present at the Field on a daily basis.

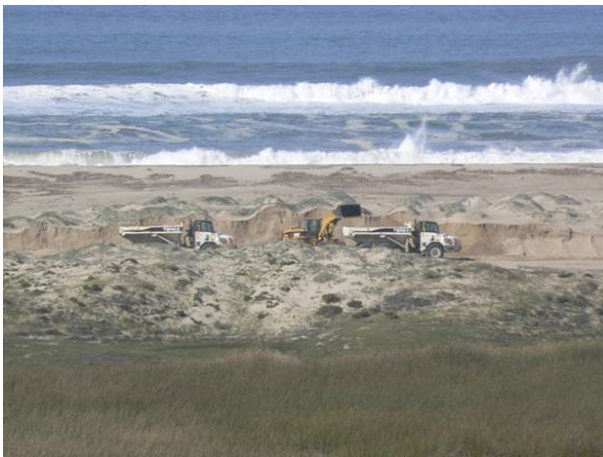
A Road removal.

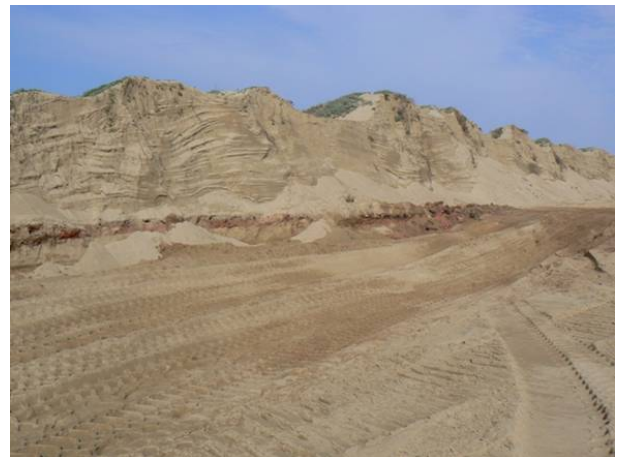
A Road removal; note layer of red rock and road base that will remain in place to preserve functioning foredune habitat above.

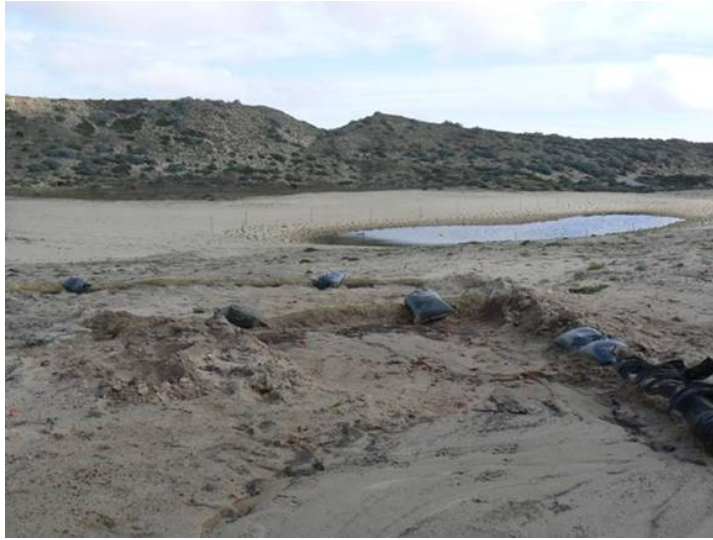
N12 Created wetland: SWPPE repairs (note erosion features) were required at this and several areas on the site during the last storms.

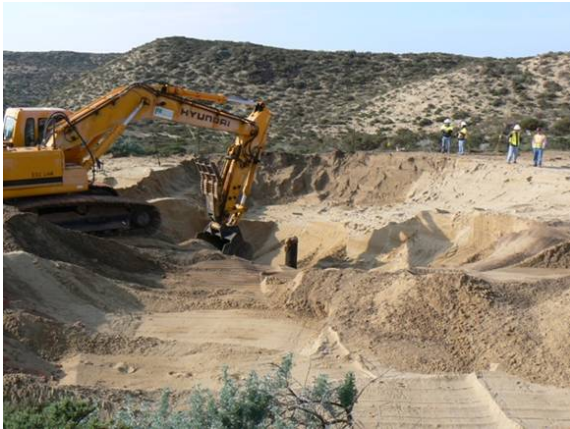
F11 pad and access road removal. Diluent-contaminated soils were exposed (more than 8 feet deep) during the removal of the redrock and base material on the pad site. Chevron is currently “chasing” contamination and coordinating with the RWQCB.

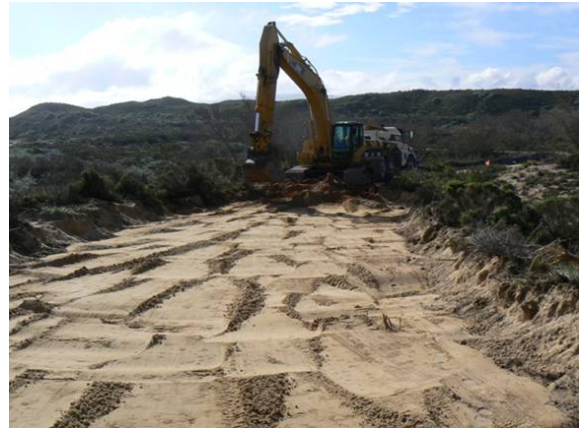
Q5 access road removal.
