County of San Luis Obispo Onsite Environmental Coordinator
Guadalupe Weekly Update 03-10-2010

Major construction/remediation activities continue at the Chevron Guadalupe Oil Field Remediation Site (Field) this week. The San Luis Obispo County Onsite Environmental Coordinator (OEC) continues to be present at the Field on a daily basis.

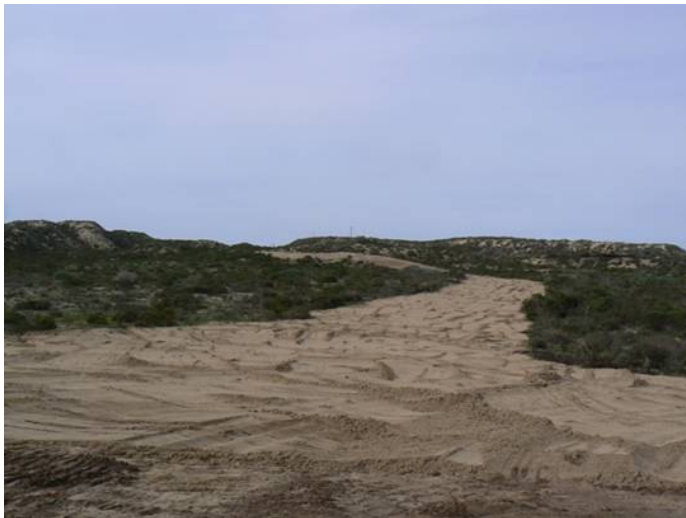
- Chevron completed remediation activities at the F11 pad and access road. A production well and diluent-contaminated sand were encountered during the removal of the pad site. Due to the depth to groundwater (more than 30 feet below the observed contamination), Chevron coordinated with the RWQCB and proceeded with backfilling the site and restoring the remainder of the access road.
- The pad site and access road were backfilled and vegetated overburden was placed on top.

F11 Pad and access road: final contours.

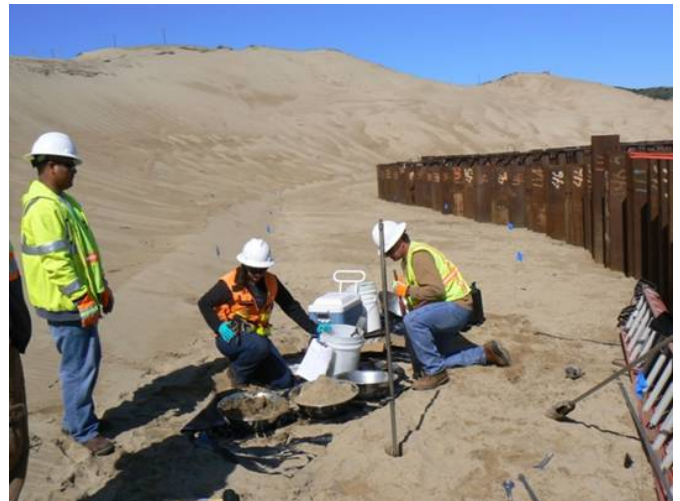
- Recon is currently installing dewatering wells and the dewatering line in the B5A excavation. During installation of the dewatering wells along the southwest side of the excavation, contaminated material was discovered up to the sheetpile wall above 1,000 ppm TPH indicating that the sheetpile wall may not encompass all of the contamination in this area. Hand auger samples from approximately 15-20 feet outside the sheetpile wall were collected last week;

B5A: collecting hand augers outside the sheetpile wall to characterize extent of contamination south of remediation site.

further step-out samples will be necessary; Chevron is currently coordinating with the RWQCB to determine additional data needs and approach.

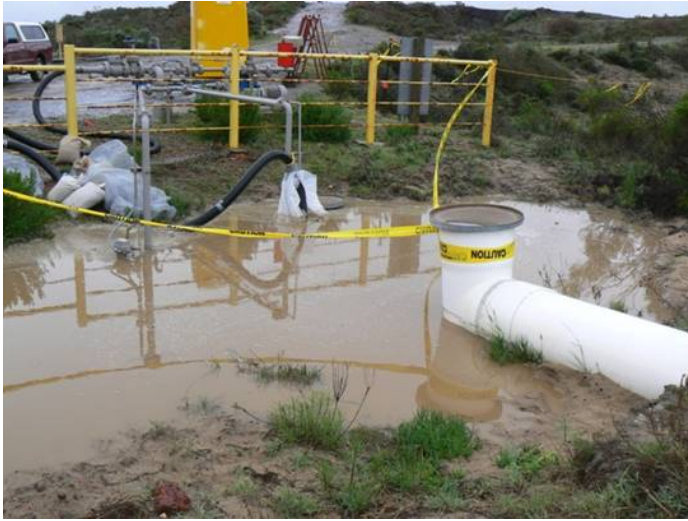
TB9 Stockpile Site: contaminated storm-water runoff overflowed containment.

- Last week, during a heavy rain downpour, the sump pump at TB9 basin overflowed with a large amount of affected water on the ground surface (see photo above).

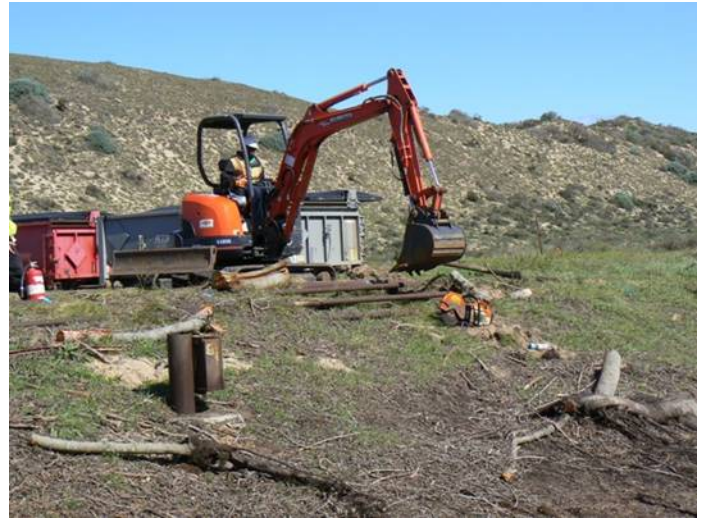
- Chevron is removing abandoned pipelines at the M12 site in preparation of remediation activities on this site. The pipelines are both inside and outside the future M12 excavation site. Pipelines are hot-tapped and cut on-site and loaded into roll-off bins staged on the M12 pad.

M12 Pipeline removal.

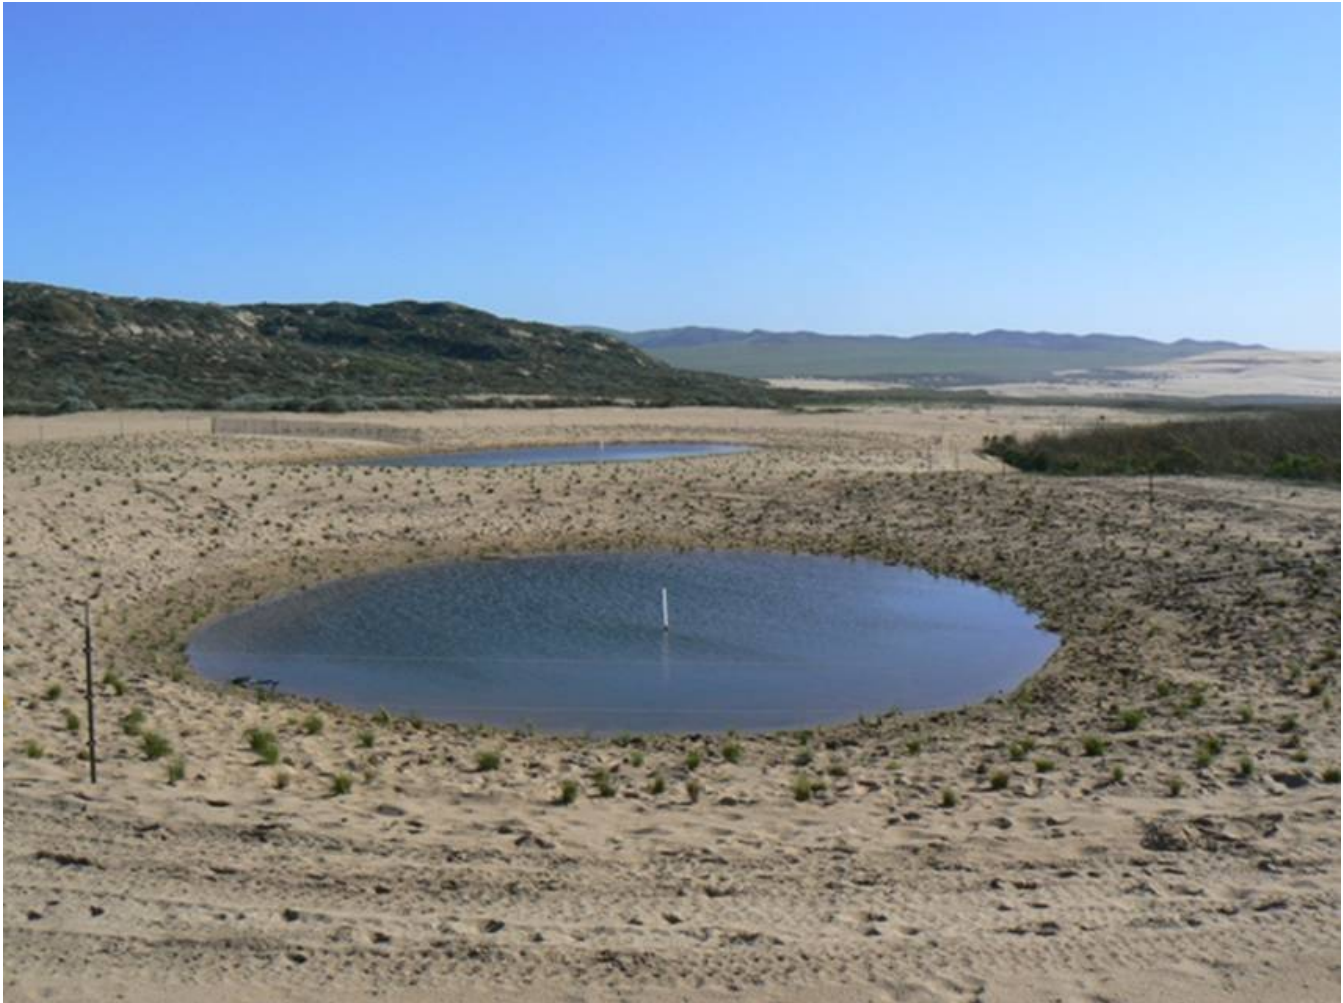
- Chevron reports that over 8,000 wetland plants were planted (all grown at the on-site growing facility) this year at the active wetland restoration sites.

TB1 Created Wetland: some of the 1,000s of new plants planted in the created wetland sites this year.
