County of San Luis Obispo Onsite Environmental Coordinator
Guadalupe Weekly Update 07-8-2010

Construction/remediation activities continue at the Chevron Guadalupe Oil Field Remediation Site (Field) this week. The San Luis Obispo County Onsite Environmental Coordinator (OEC) continues to be present at the Field on a daily basis.

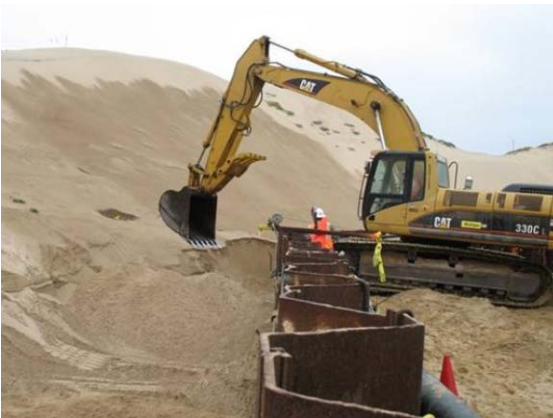
Excavating one of six trenches outside the B5A Excavation Site.

Chevron construction contractor, Entact, has completed the excavation of contaminated material outside the B5A Sheetpile wall. Excavation began on June 28 and was completed on July 7. The excavation activities included removing a portion of the known contamination outside the sheetpile wall in a series of six trenches running perpendicular to the sheetpile wall, collecting a soil sample from the bottom of each excavated trench, and immediately backfilling with clean sand.

Contaminated soil and free floating product was visible at each of the six excavated trenches. Entact was able to excavate contaminated material up to approximately 12 to 15 feet past the sheetpile wall. Further excavation was restricted due to the presence of a natural dune immediately to the south of the excavated trenches.

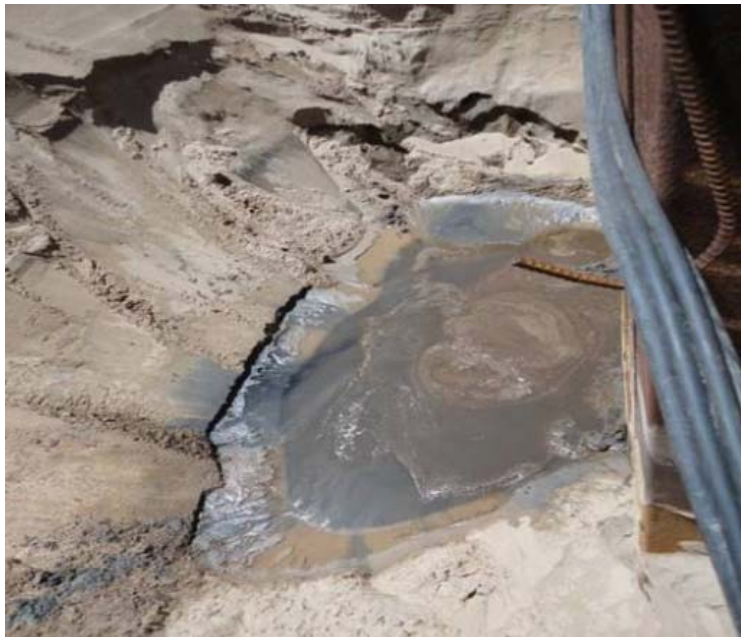
Some of the free floating product that remained in place after the B5A excavation of material outside the sheetpile wall.
